Concrete and the People's Cathedral

The Cathedral Church of the Holy Spirit in Guildford, Surrey is the last Church of England cathedral consecrated on a new site (in 1961) and one of only three CofE cathedrals built in the 20th Century. Constructed in a large part with reinforced concrete, the Grade II listed building recently underwent a major refurbishment project. Concrete report.*

Guildford Cathedral, Surrey

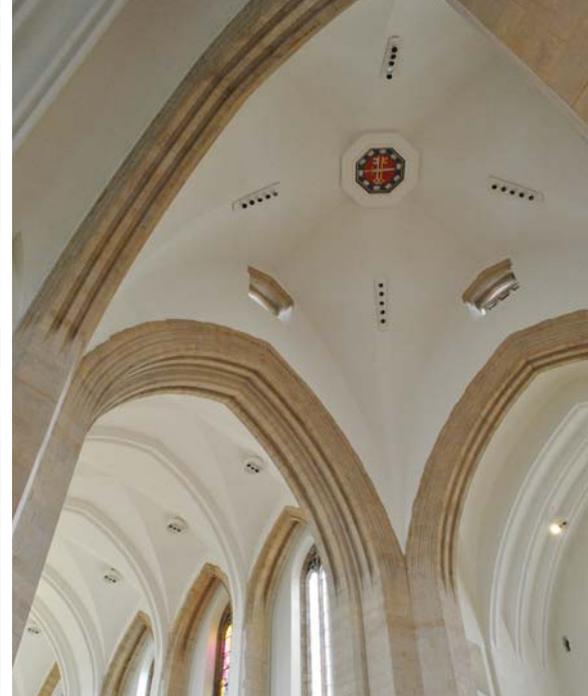
Crossing and quire ceilings after plaster removal.

The transept and crossing vaults were cast between 1947 and 1954. Again, softwood timber boarding was used but the quality of compaction was not as good. The surface was very random with patchy areas of honeycombing and several bad day joints. Reinforcement spacer blocks were evident in the surface in places. Significant areas here had to be plastered to fill the holes; just decorating the vaults would have been visually problematic.

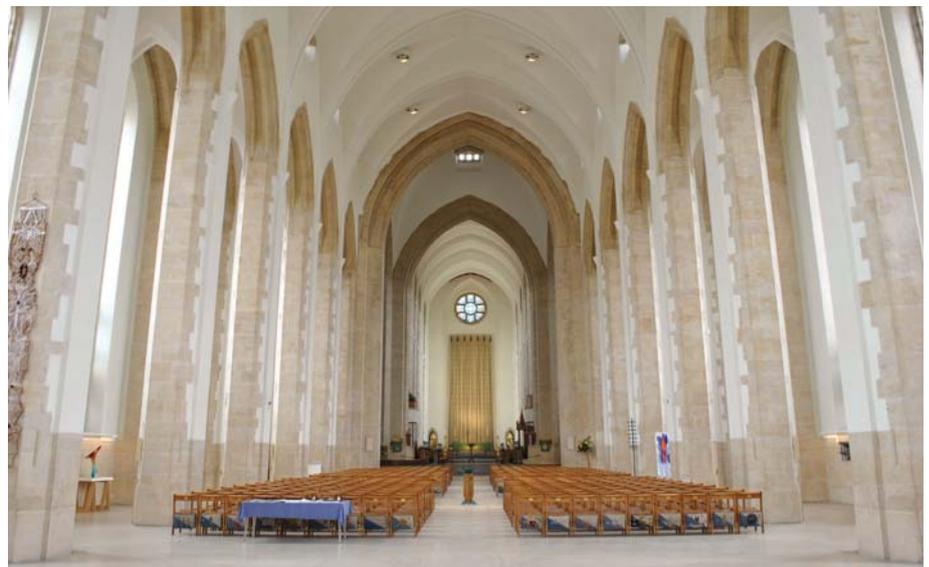
Completed cathedral following repairs, showing the sheer scale and volume of the interior.

Once the asbestos had been removed the concrete was painted with an approved elastic paint finish to seal in any fibres that may have remained. This means that should the building move, the material will not fail. This was then coloured to match the overall colour scheme in the cathedral. Where a plaster finish over this was needed, a bonding agent was used that would stick to the elastic paint with the modern plaster then applied. A stain-block sealer was needed to some vaults where a bitumen coating on the concrete was encountered.
